Case Study: Treig Dam

Physical Model Testing of Spillway for Halcrow Water

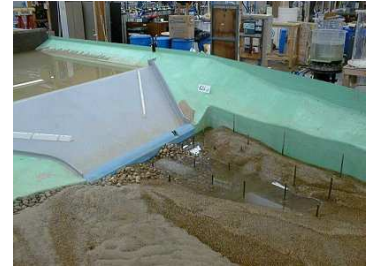
Treig Dam is a rockfill embankment dam approximately 12m high. The spillway is located on the embankment with the spillway crest formed by the top of the core wall. The flow passes down the spillway over concrete slabs cast directly on the rockfill, which forms the sloping downstream face. The width of the spillway decreases from 100m at the crest to 45m at the roller bucket along the toe. Side training walls and baffle walls are used to guide the flow down the spillway.

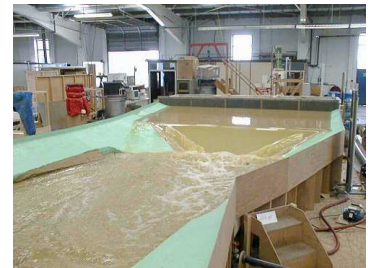
- Original design flood peak outflow 215m³/s but recent estimates indicated PMF 624m³/s
- Flood Stability Assessment Report raised concerns that high flood flows could cause excessive erosion at the toe of the spillway resulting in:
 - failure of protective sheet pile wall beneath the toe of the dam
 - loss of embankment fill from beneath the concrete slabs
 - endangering the structural integrity of the dam.

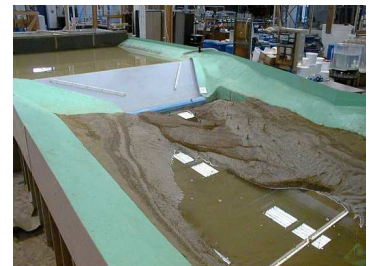
A 1:30 scale model of the Treig Dam was constructed to assess the performance of the spillway at a range of discharges up to the equivalent to the 1 in 10000 year peak flood and the Probable Maximum Flood (PMF). The installation of a mobile bed section enabled the extent and magnitude of the erosion of the downstream terrain to be investigated.

A rockfill apron positioned immediately downstream of the roller bucket was found to prevent severe erosion of the bed material local to the spillway at discharges up to the PMF. This ensured that a sheet-piling wall previously installed along the toe of the spillway would be protected. Structural modifications were recommended to contain the flow within the confines of the spillway.
