Case study No.1: Malaysian Dam Spillway

Physical model study for the determination of the flow patterns downstream of the spillway

Case Study No.2: Treig Dam

Mobile Bed Study for Halcrow Water

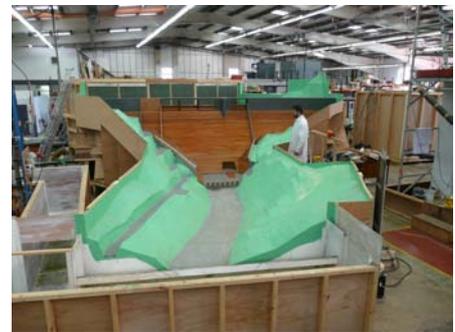
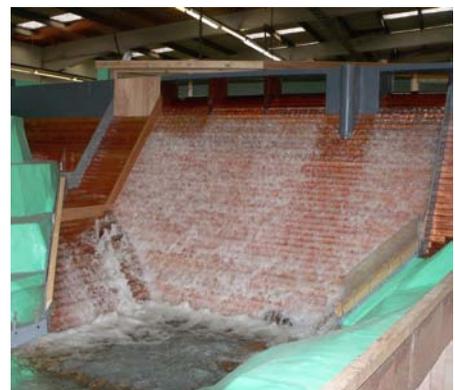
Modifications to the physical model were made in three stages; flow detachment was reduced through a series of tests with various block arrangements on the spillway steps; blocks were added to the stilling basin for the containment of the hydraulic jump; the southernmost spillway opening was closed to observe the effects on the upstream levels and amount of water on the sidewalls. Finally, lips were added to the sidewalls to deflect the flow back onto the spillway.

During the initial tests, a detachment of the flow from the initial steps was observed downstream of the bridge for the five spillway openings. High velocities were measured on one side of the riverbank due to the non-symmetrical design of the spillway. At the higher flow rates, a significant proportion of the flow was overtopping the sidewalls.

As a result of the physical model testing, specific recommendations were made to optimise the initial outline design to improve the energy dissipation of the spillway and to ensure that the hydraulic jump was contained on the stilling basin at the design flow rate.

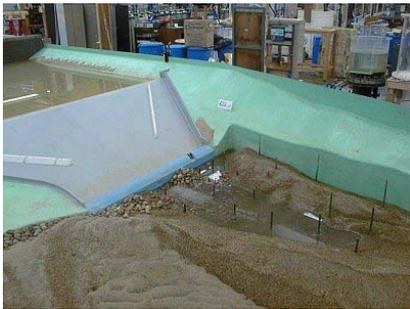
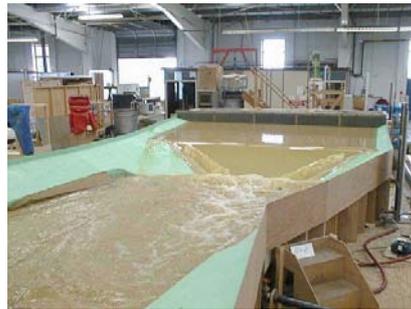
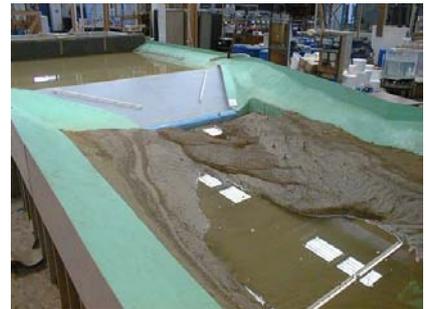
Treig Dam is a rockfill embankment dam approximately 12m in height. The spillway is located on the embankment with the spillway crest formed by the top of the core wall. The flow passes down the spillway over concrete slabs cast directly on the rockfill, which forms the sloping downstream face. The width of the spillway decreases from 100m at the crest to 45m at the roller bucket along the toe. Side training walls and baffle walls are used to guide the flow down the spillway.

A 1:30 scale model of the dam was constructed to assess the performance of the spillway at a range of discharges up to the equivalent to the 1 in 10,000 year peak flood and the Probable Maximum Flood (PMF). The installation of a mobile bed section enabled the extent and magnitude of the erosion of the downstream terrain to be investigated.

A rockfill apron positioned immediately downstream of the roller bucket was found to prevent severe erosion of the bed material local to the spillway at discharges up to the PMF. This ensured that a sheet-piling wall previously installed along the toe of the spillway would be protected. Structural modifications were recommended to contain the flow within the confines of the spillway.
